Release Notes

Document No.: RN-260105-02
Date: January 05, 2026
Classification: External
Attn: End customer
Related Products: GX100, GX100PM
Subject: **Legacy GX series iARM (1.14) and Firmware**

Intellian is pleased to release iARM packages and FW for the Intellian antenna systems. This update primarily addresses the need to support board changes due to the End-of-Life (EOL) of the Sharp Tuner and Gyro Tilt Sensor.

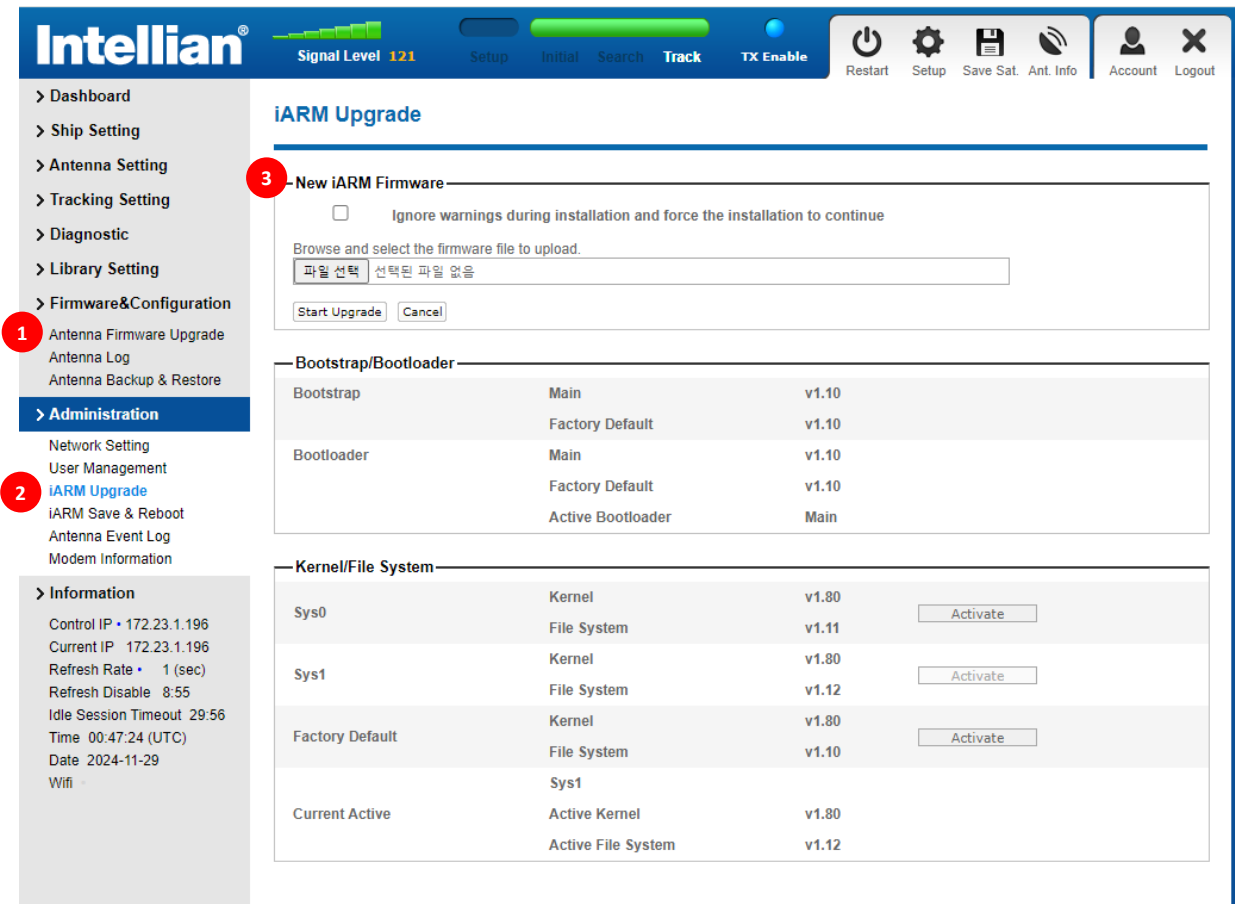
No.	Item	Description
①	FW upgrade	Upgrade the firmware of antenna.
②	iARM Upgrade	Upgrade the firmware of iARM module.
③	New Firmware	iARM Select Upgrade Method between Manual Upgrade or Auto Upgrade. With Manual Upgrade option selected, browse and select the firmware file to upload and click Start Upgrade button. With Auto Upgrade option selected, click Check button to check automatically if there is new firmware available from the server.

iARM firmware upgrade procedures:

1. Click on “Browse” button to select the iARM firmware file (.tgz) that you wish to upgrade. In Auto Upgrade mode, check new firmware file automatically by clicking Check button.
2. Click on “Start Update” button to update the iARM firmware. Wait until the page is loaded. In Auto Upgrade mode, click "Upgrade" button once new firmware file is detected.
3. It'll inform you that the firmware is being uploaded.
