Document No.: RN-260410-01
Date: 10th April, 2026
Classification: External
Attn: Inmarsat
Related Products: GXNX series
Subject: Release of Hotfix Firmware for GXNX Series (V2.51.018)

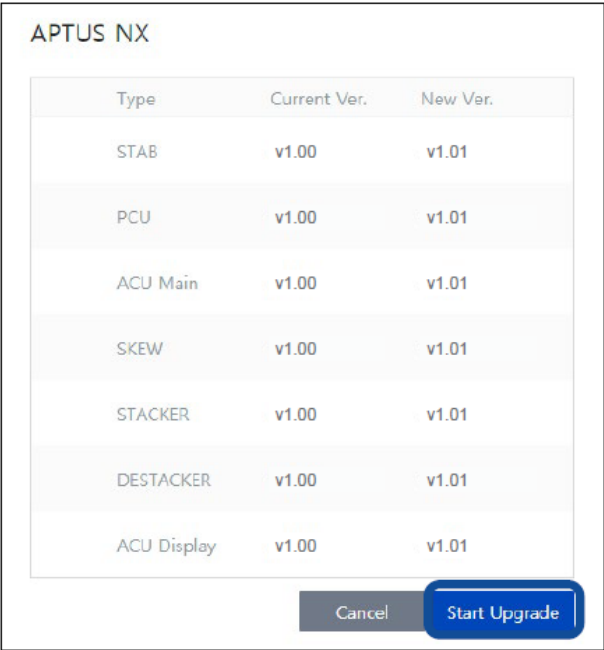
4. Check the current version installed and the new version available, then click the **Start Upgrade** button.

APTUS NX

Type	Current Ver.	New Ver.
STAB	v1.00	v1.01
PCU	v1.00	v1.01
ACU Main	v1.00	v1.01
SKEW	v1.00	v1.01
STACKER	v1.00	v1.01
DESTACKER	v1.00	v1.01
ACU Display	v1.00	v1.01

Buttons: Cancel, Start Upgrade
