Document No.: RN-260410-03
Date: 10th April, 2026
Classification: External
Attn: JRC
Related Products: JUE100GX
Subject: Release of Hotfix Firmware for JUE100GX (V2.51.018)

Intellian is pleased to release updated firmware for the JUE100GX. This hotfix addresses specific issues identified in the production process and field operations to ensure improved system stability. It is recommended to apply this update at the next service opportunity.

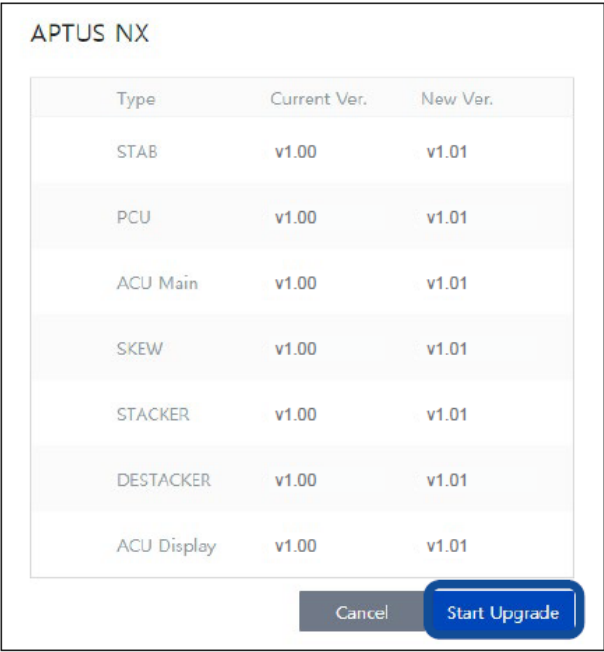
4. Check the current version installed and the new version available, then click the **Start Upgrade** button.

Type	Current Ver.	New Ver.
STAB	v1.00	v1.01
PCU	v1.00	v1.01
ACU Main	v1.00	v1.01
SKEW	v1.00	v1.01
STACKER	v1.00	v1.01
DESTACKER	v1.00	v1.01
ACU Display	v1.00	v1.01

Buttons: Cancel, Start Upgrade
